66-inch Storm Sewer Replacement
Construction Completion Report

This *66-inch Storm Sewer Replacement Construction Completion Report (CCR)* describes the activities that were performed to replace a section of the storm sewer at the NYSEG Court Street Former Manufactured Gas Plant (MGP) Site (the site) located in Binghamton, New York. This CCR was prepared by ARCADIS of New York, Inc. (ARCADIS), on behalf NYSEG. The activities described herein were conducted in general conformance with the *66-inch Storm Sewer Replacement Design Report (Design Report)* (ARCADIS, 2011), which was approved by the New York State Department of Environmental Conservation (NYSDEC) in a July 13, 2011 letter.

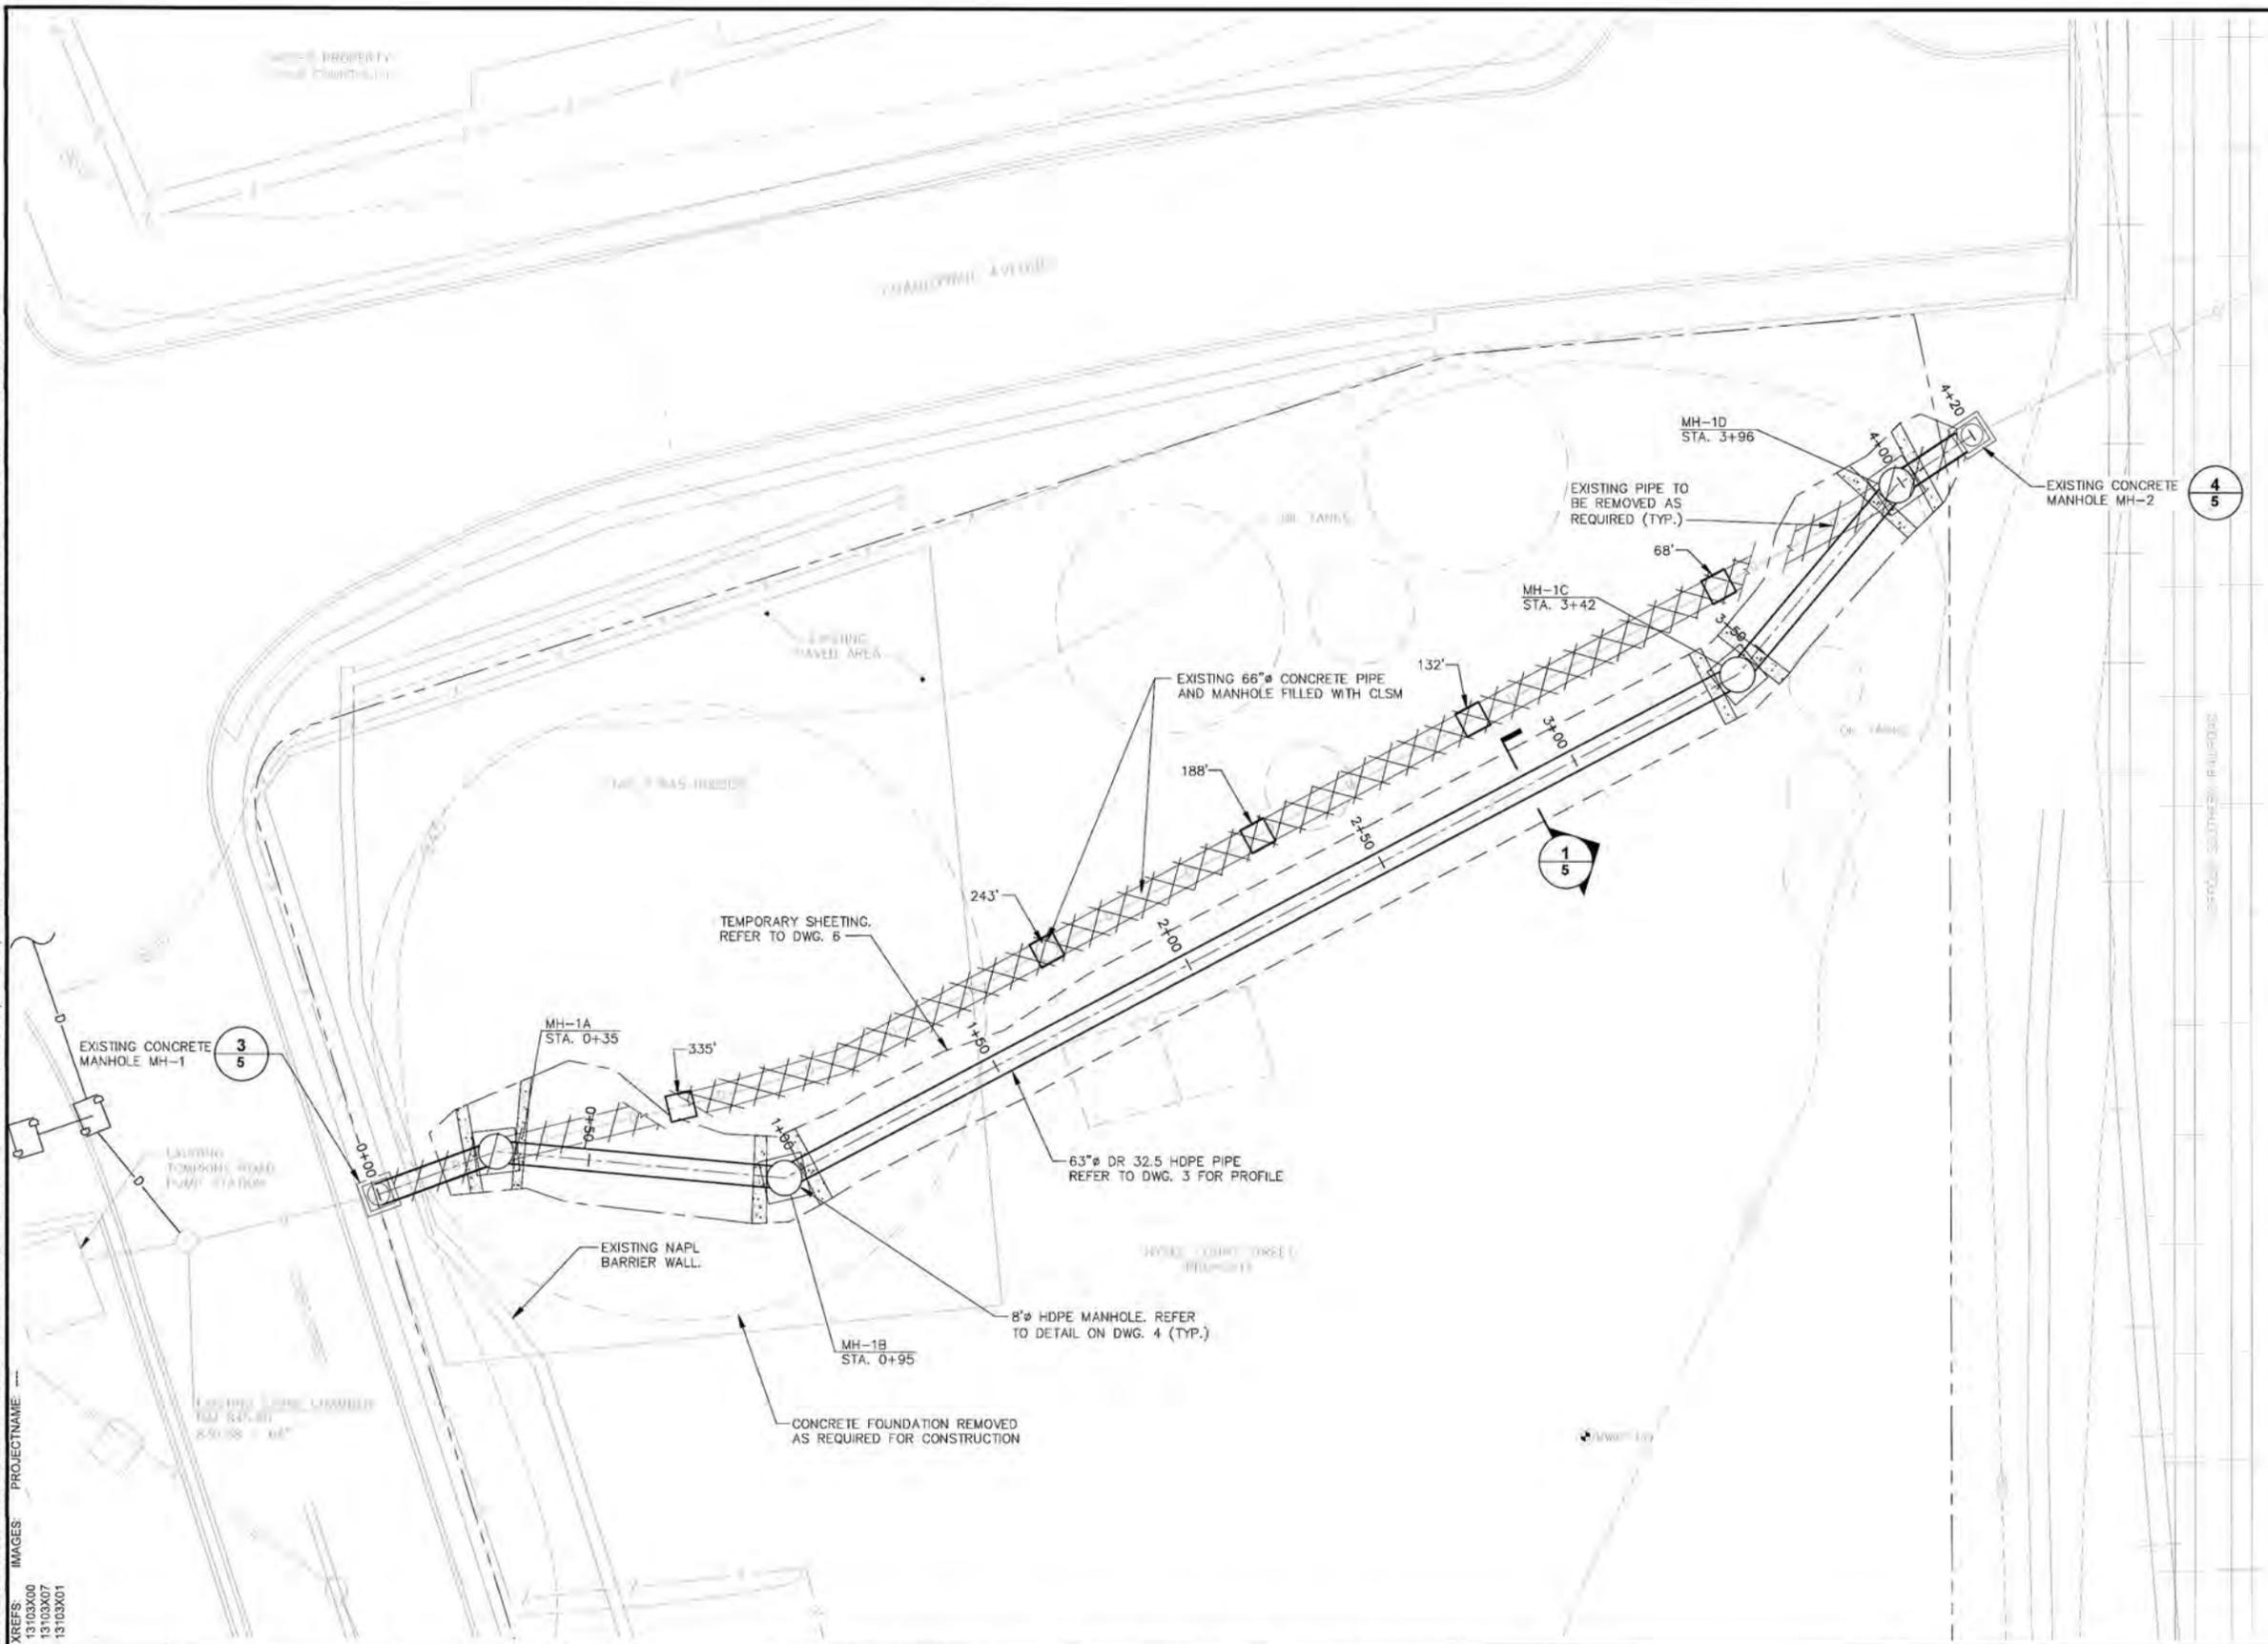
- LEGEND:**
- LIMITS OF TEMPORARY SHEETING/ IMPORTED FILL (PHASE I)
 - LIMITS OF TEMPORARY SHEETING/ IMPORTED FILL (PHASE II)
 - I HP10X54
 - WOOD LAGGING
 - PRE-EXISTING RCP STORM SEWER ACCESS POINT FOR CLSM BACKFILL (DISTANCES RELATIVE TO MANHOLE MH-2)
 - CONCRETE COLLAR
 - ▨ REMOVED PORTIONS OF PRE-EXISTING RCP
 - ▩ ABANDONED SECTION OF RCP FILLED WITH CLSM

- NOTES:**
- SHEET PILING CONSISTED OF GRADE 50, AZ-48 STEEL SHEET PILING, INSTALLED TO THE DEPTHS AND LIMITS AS INDICATED ON THE CONTRACT DOCUMENTS.
 - ALL SITE FEATURES AND LOCATIONS ARE APPROXIMATE.
 - LOCATIONS, SIZES, DEPTHS, AND MATERIALS ASSOCIATED WITH SUBSURFACE PIPING OBTAINED FROM NYSEG REPORT ENTITLED "INTERIM REMEDIAL MEASURES FINAL ENGINEERING REPORT" (JULY 2002).

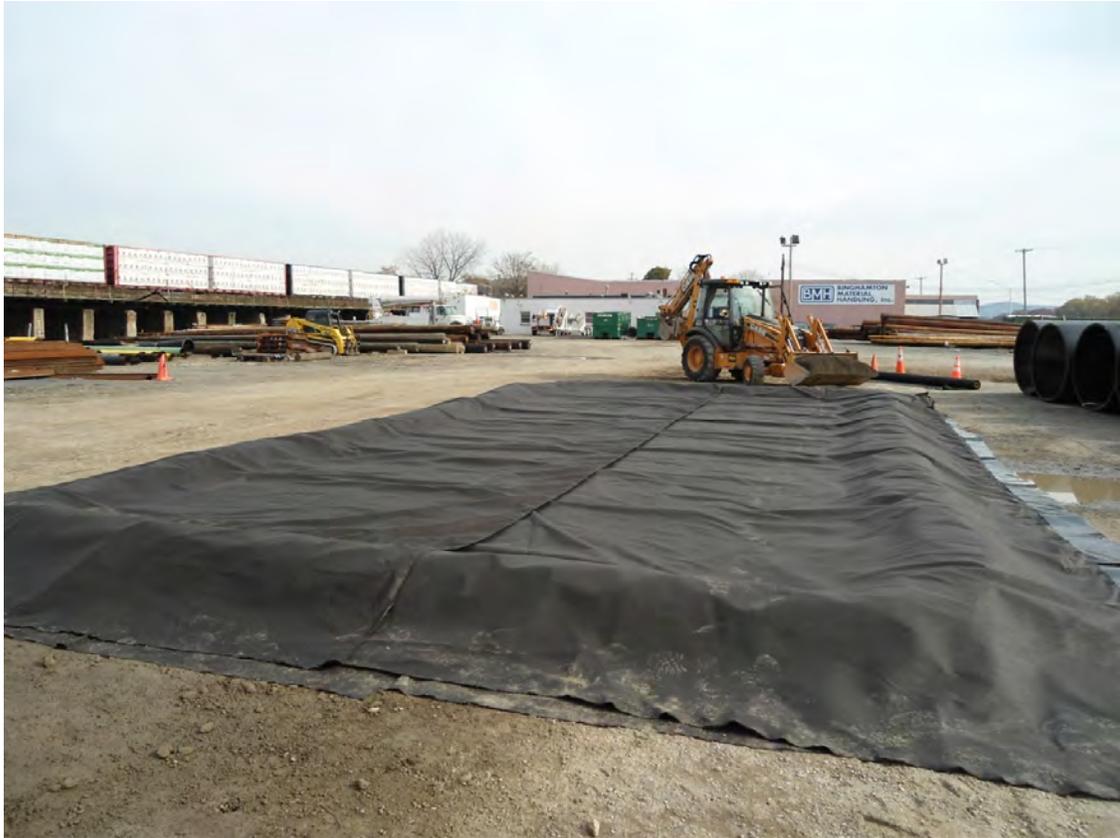
Decontamination Pad liner system (non-woven-geotextile – HDPE liner – non-woven geotextile)

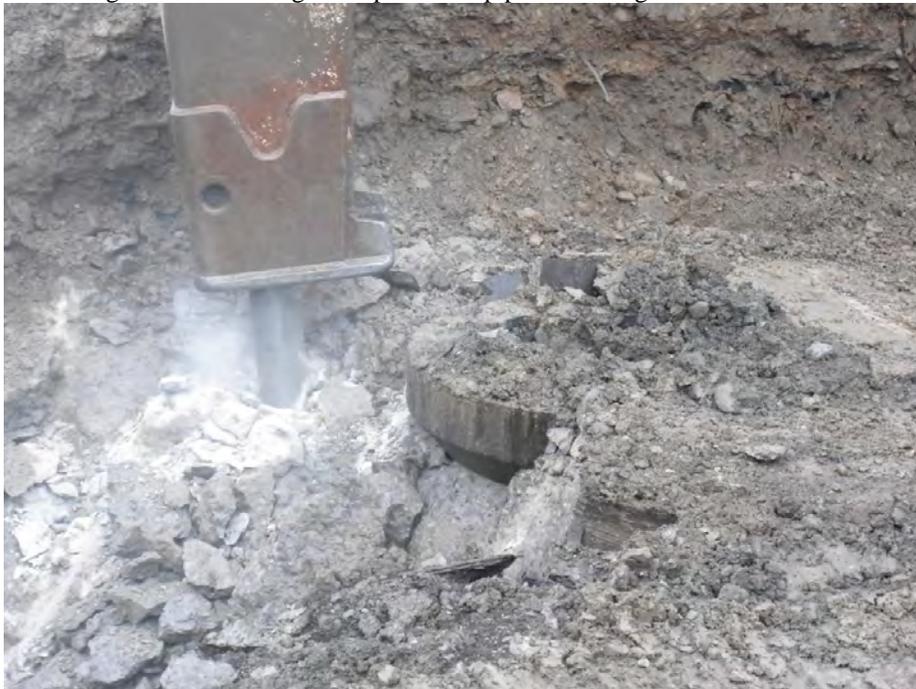
No. 4 Gas Holder foundation demolition, 30" diameter vertical iron pipe encountered

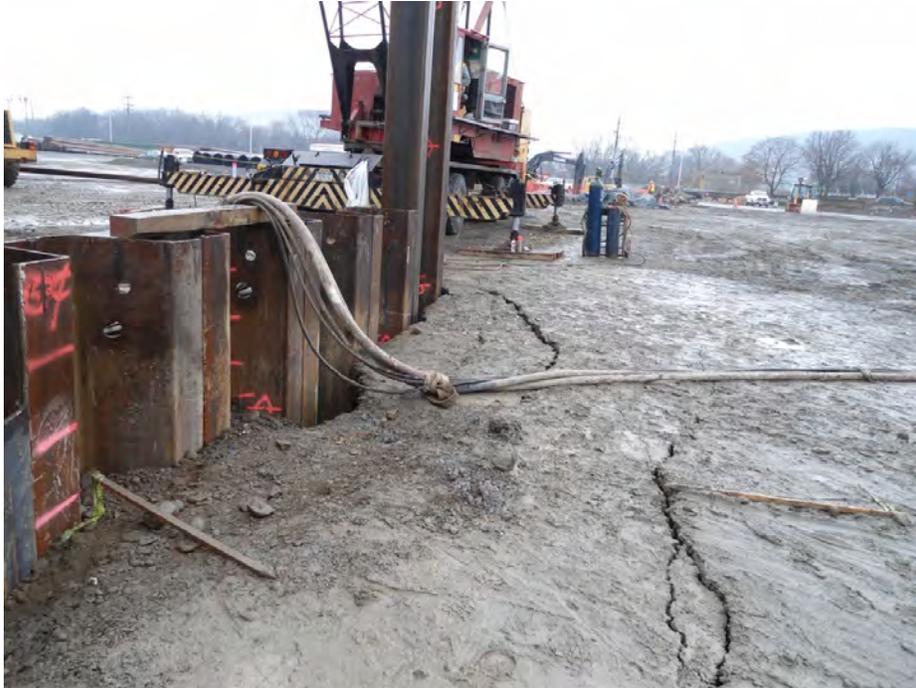
Soil compaction and cracking along west sheeting alignment

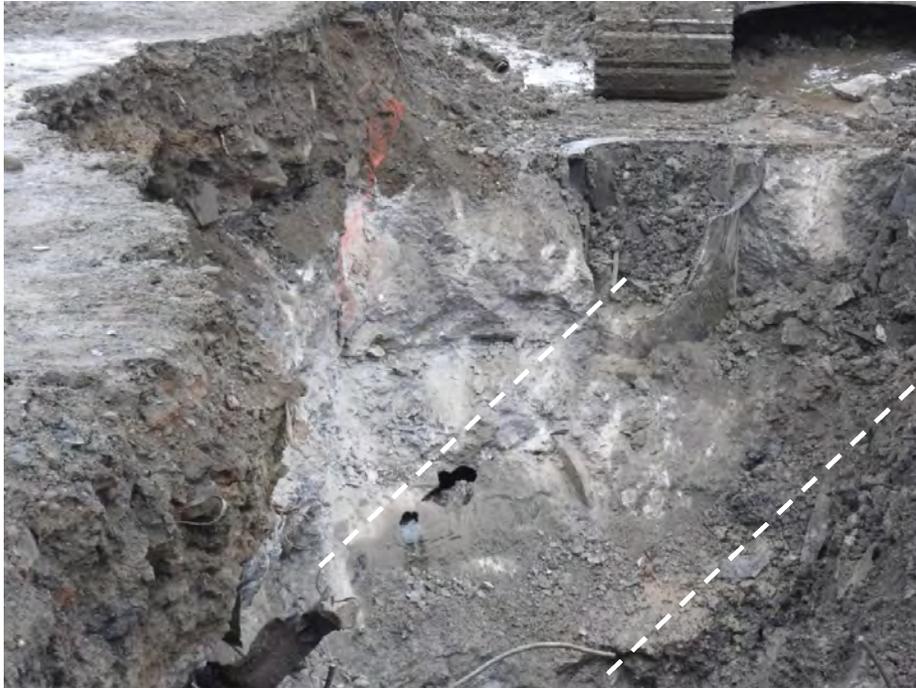
30" diameter cast iron pipe, embedded in concrete with visible coal tar product present

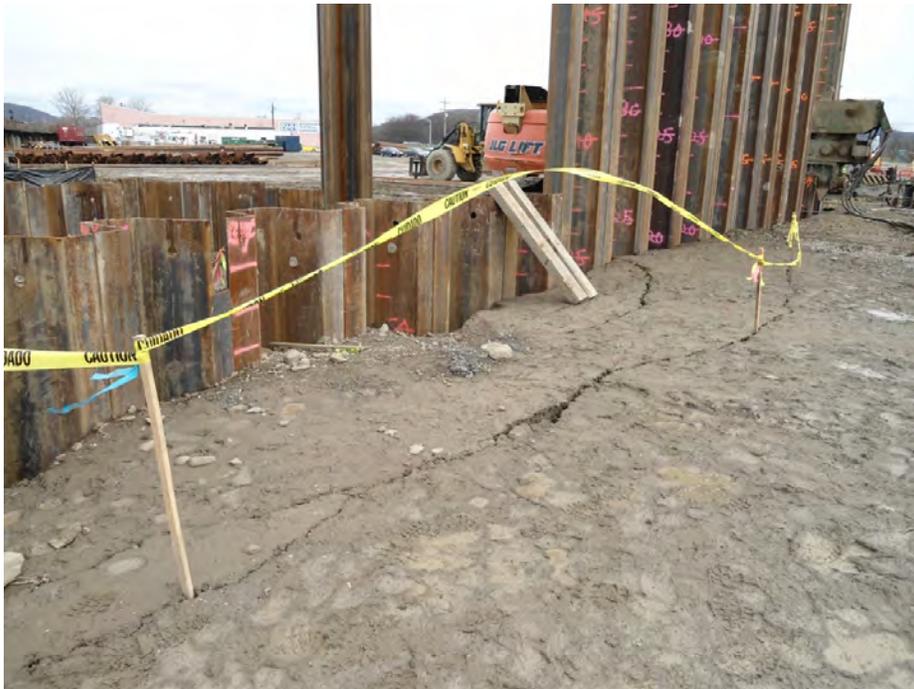
Compaction and cracking along the west sheeting alignment

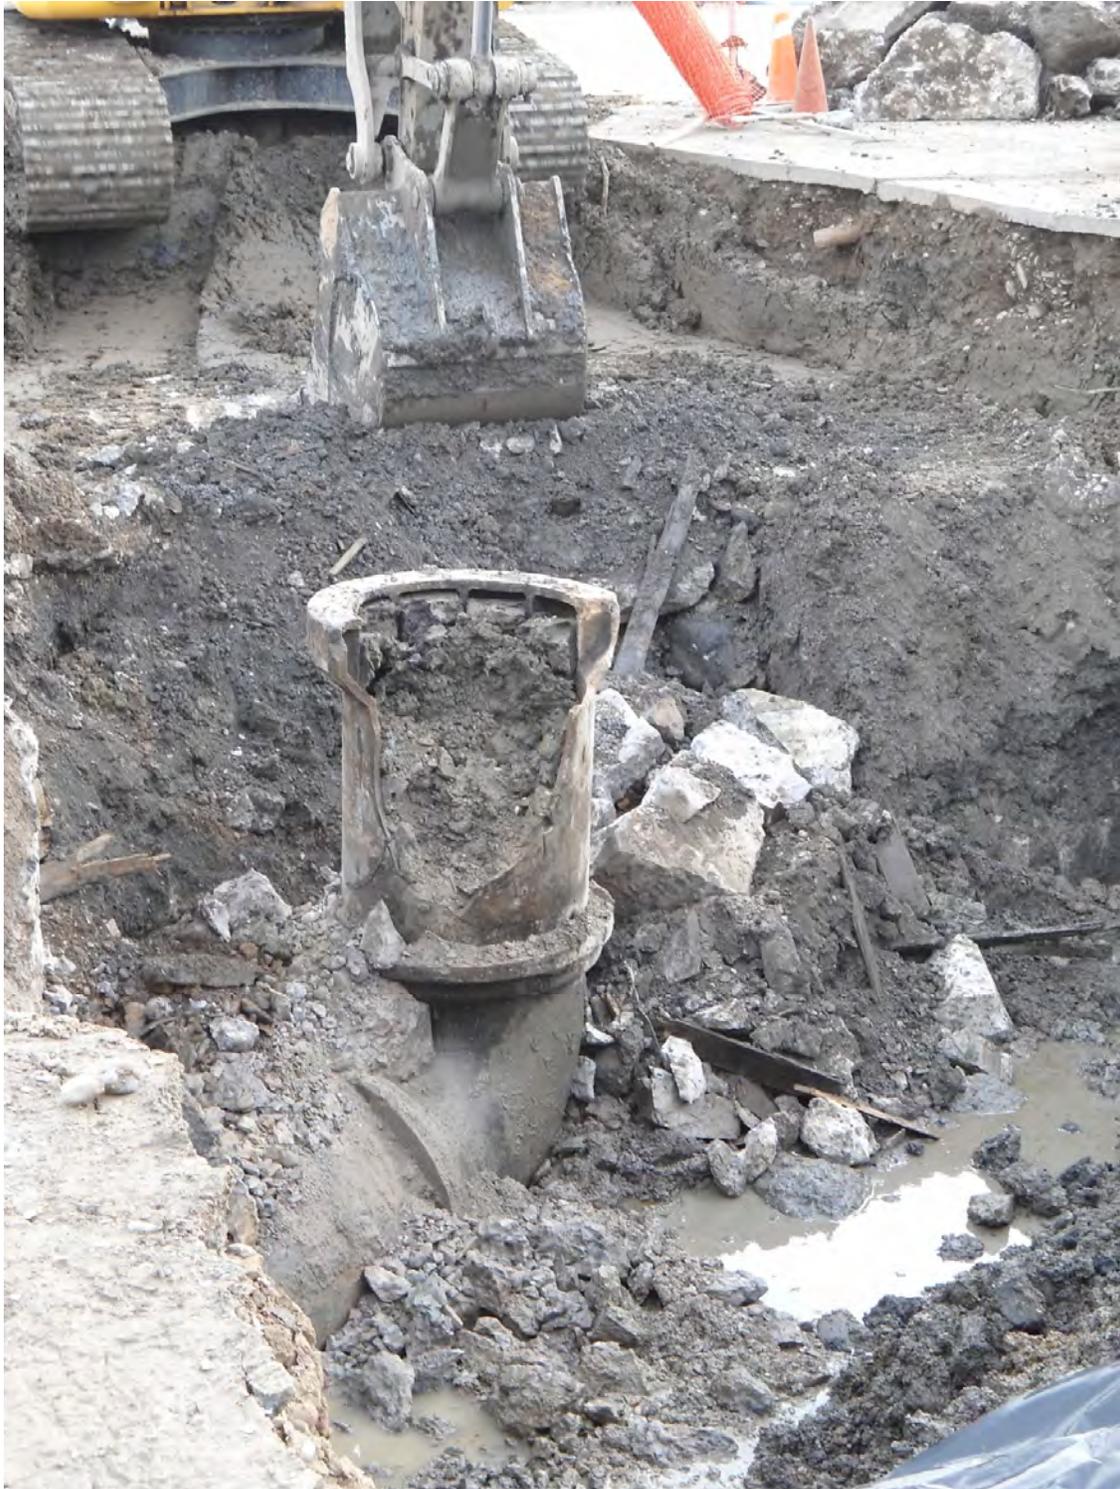
30" diameter cast iron pipe, exposed 90 degree section

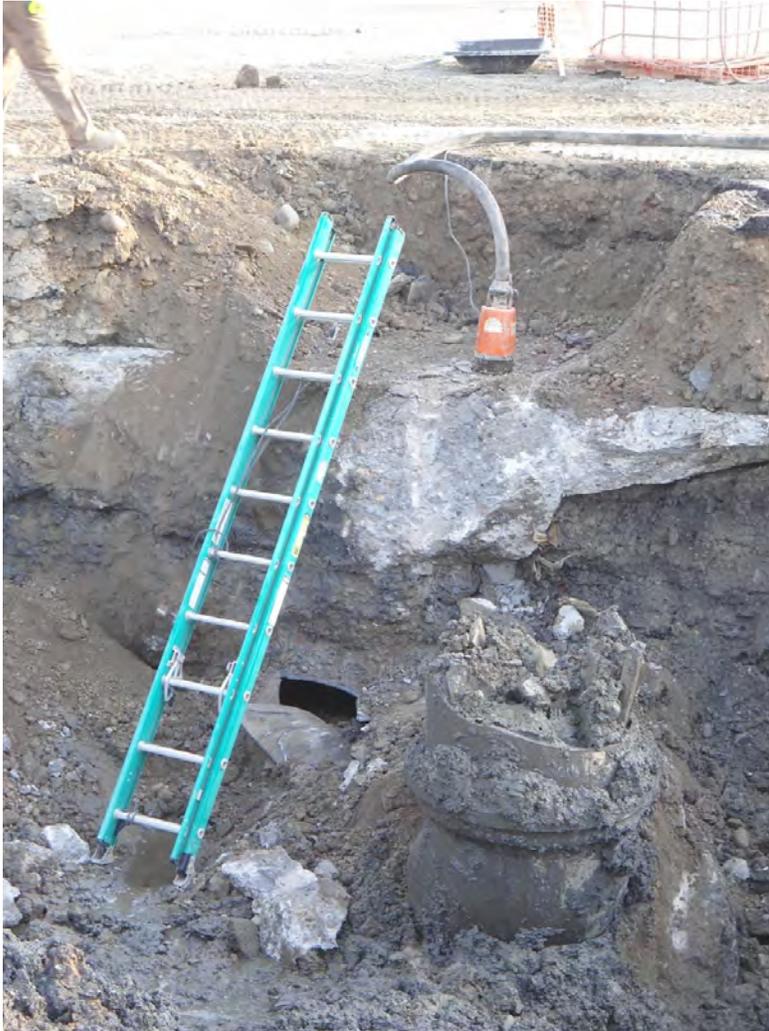
30" diameter pipe and side wall location. Initial opening in pipe was enlarged (as shown in figure) in order to remove liquid to frac tank using pump prior to continued demo and removal.

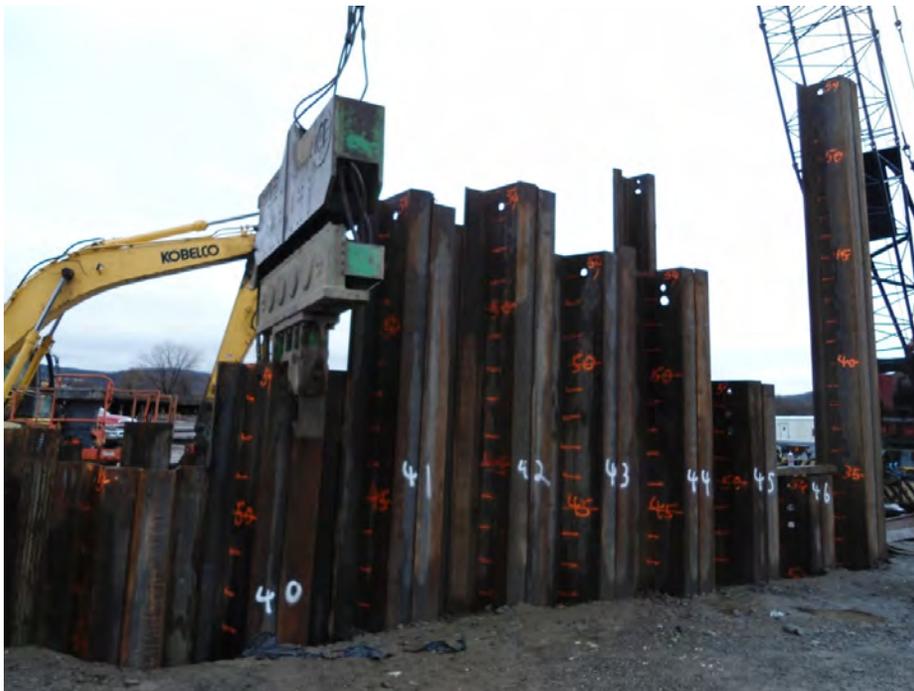
Area of problematic sheets along the west sheeting alignment. Photo was taking from the west looking left at the exterior of the sheet wall.

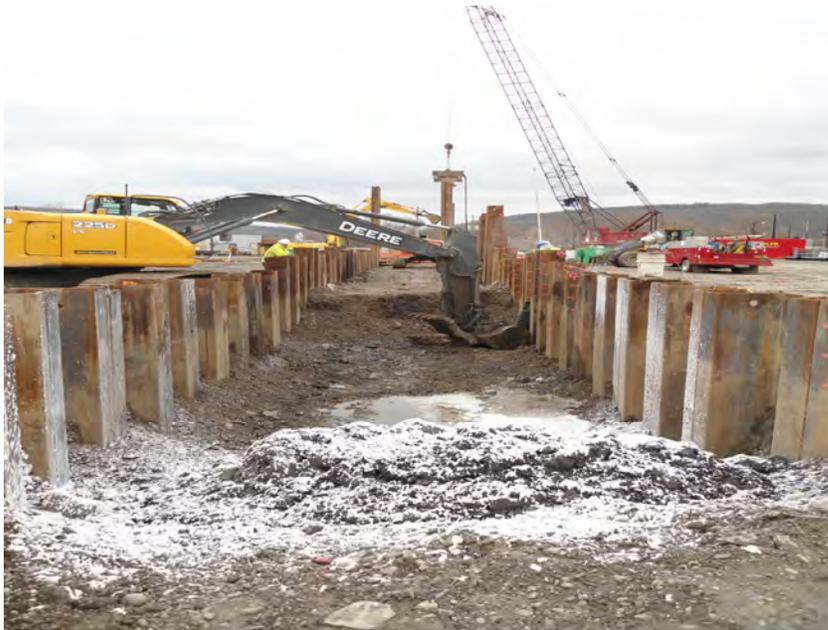
Installation of sump at leaking sheet along west alignment (facing southwest)

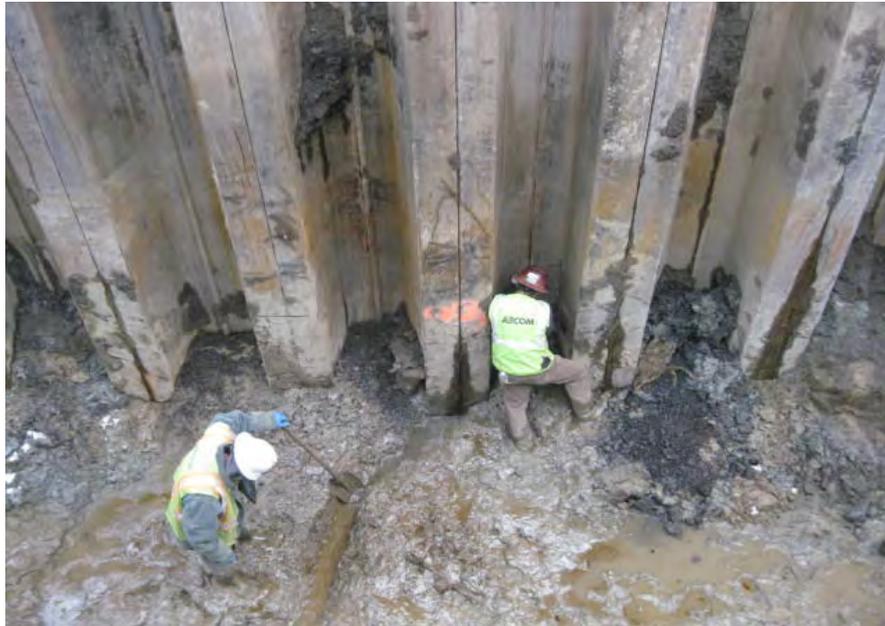
View of AECOM attempting to repair leaking sheets. Photo taken from the western sheet wall facing east into excavation

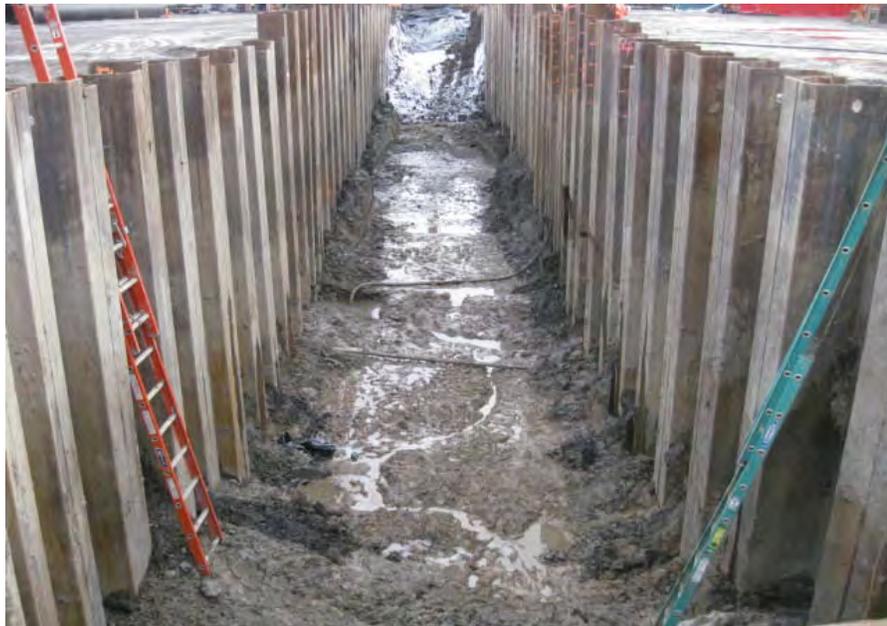
View of excavation showing water from leaks. Photo taken from north end of excavation facing down and south.

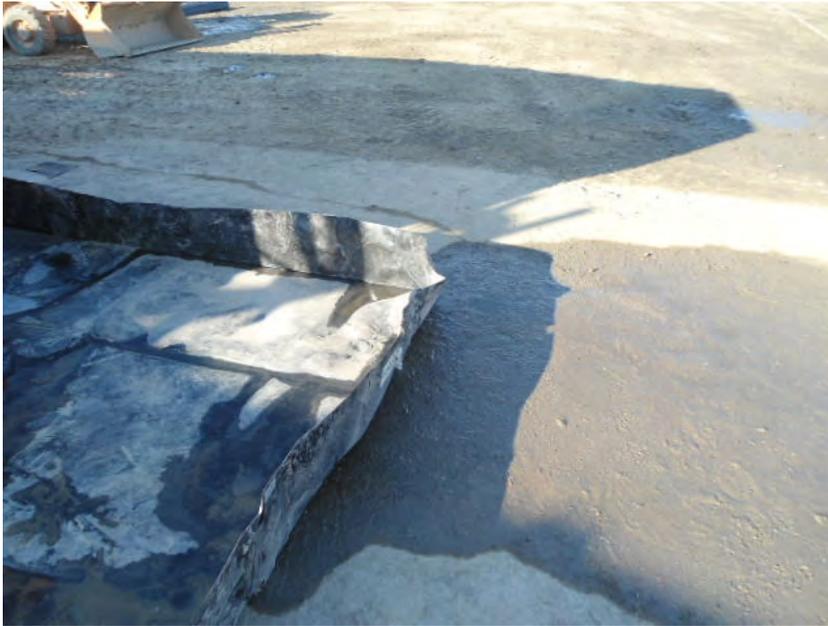
Leaks in secondary containment under Frac Tank. Photo taken at south west corner of site near TWTS.

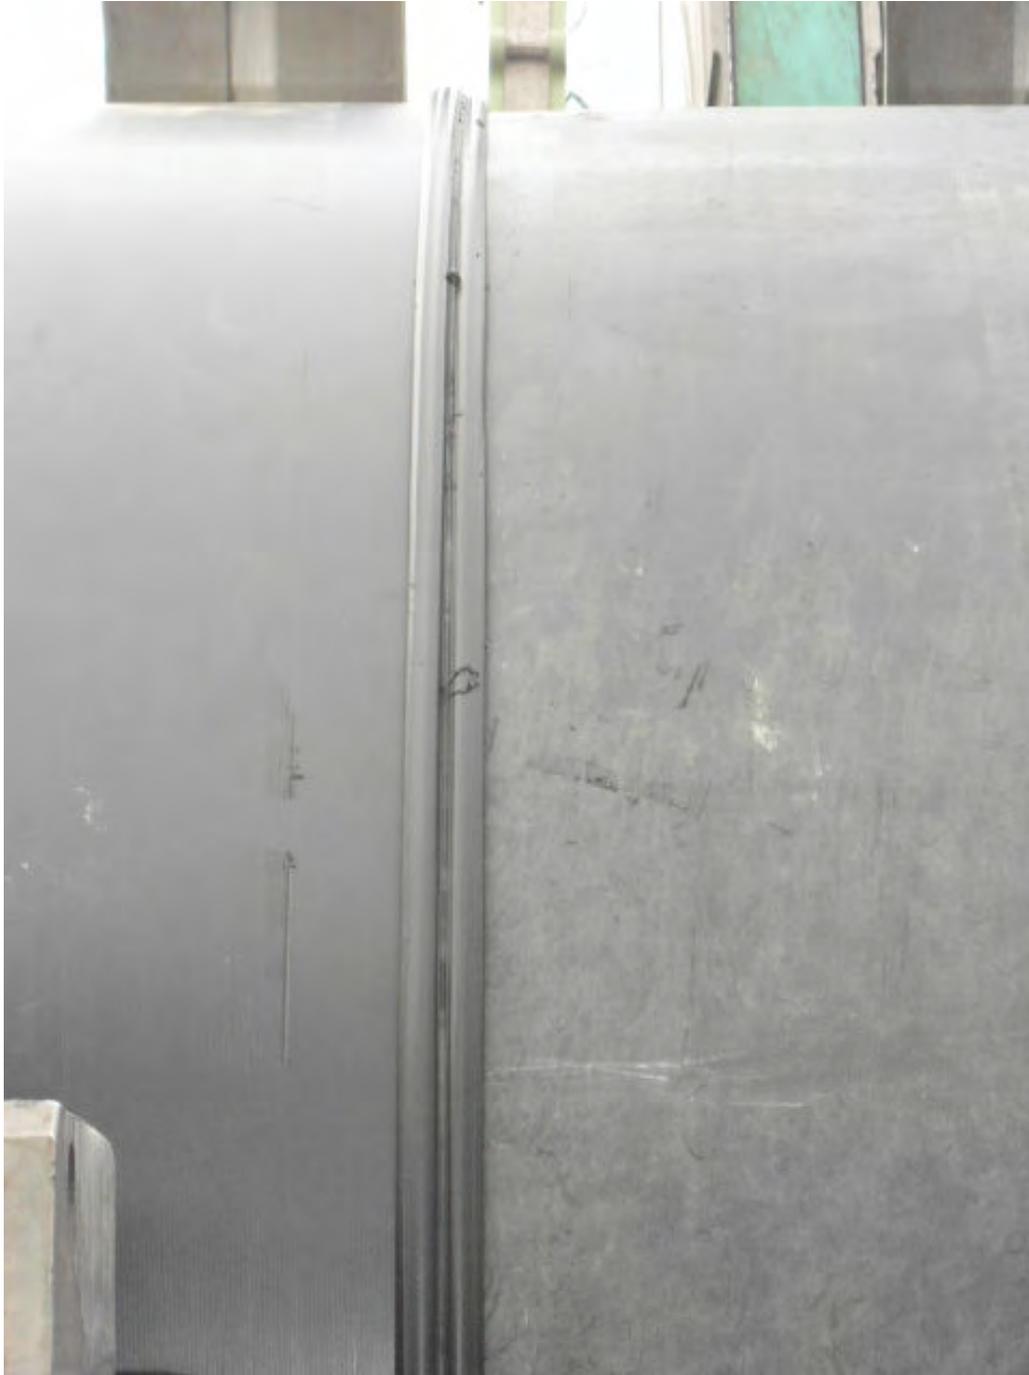
A completed butt fusion of the south flange and an approximately 54-foot section of HDPE (facing west).

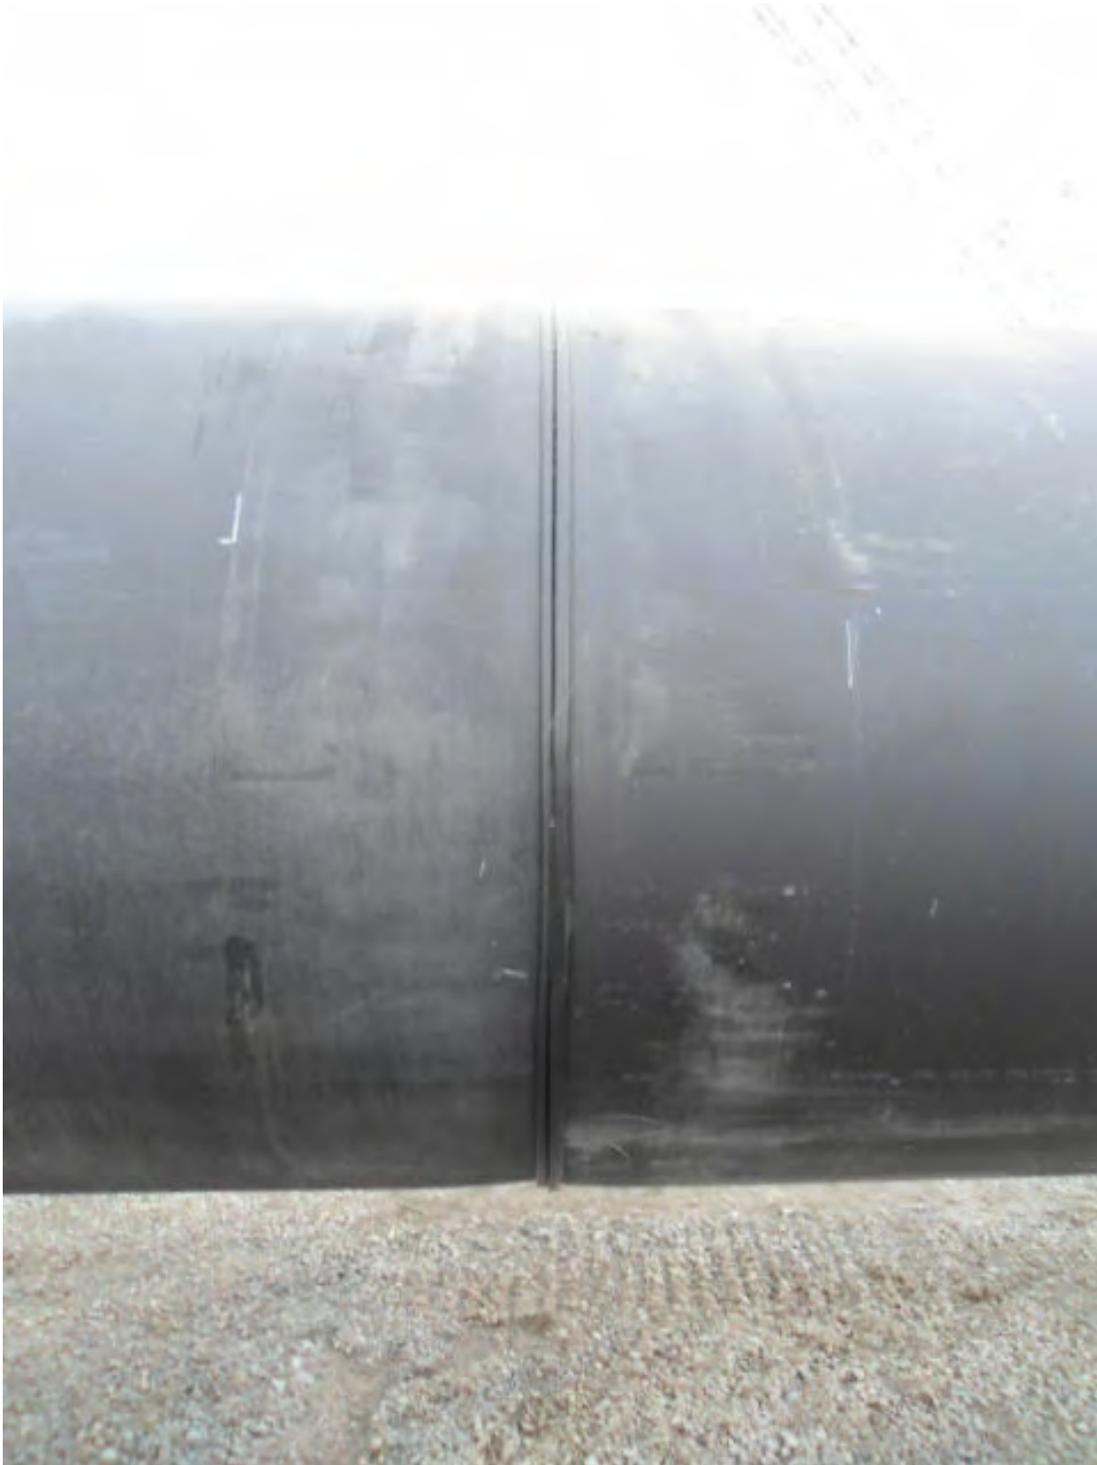
A successful butt-fusion of HDPE sections two and three (facing west).

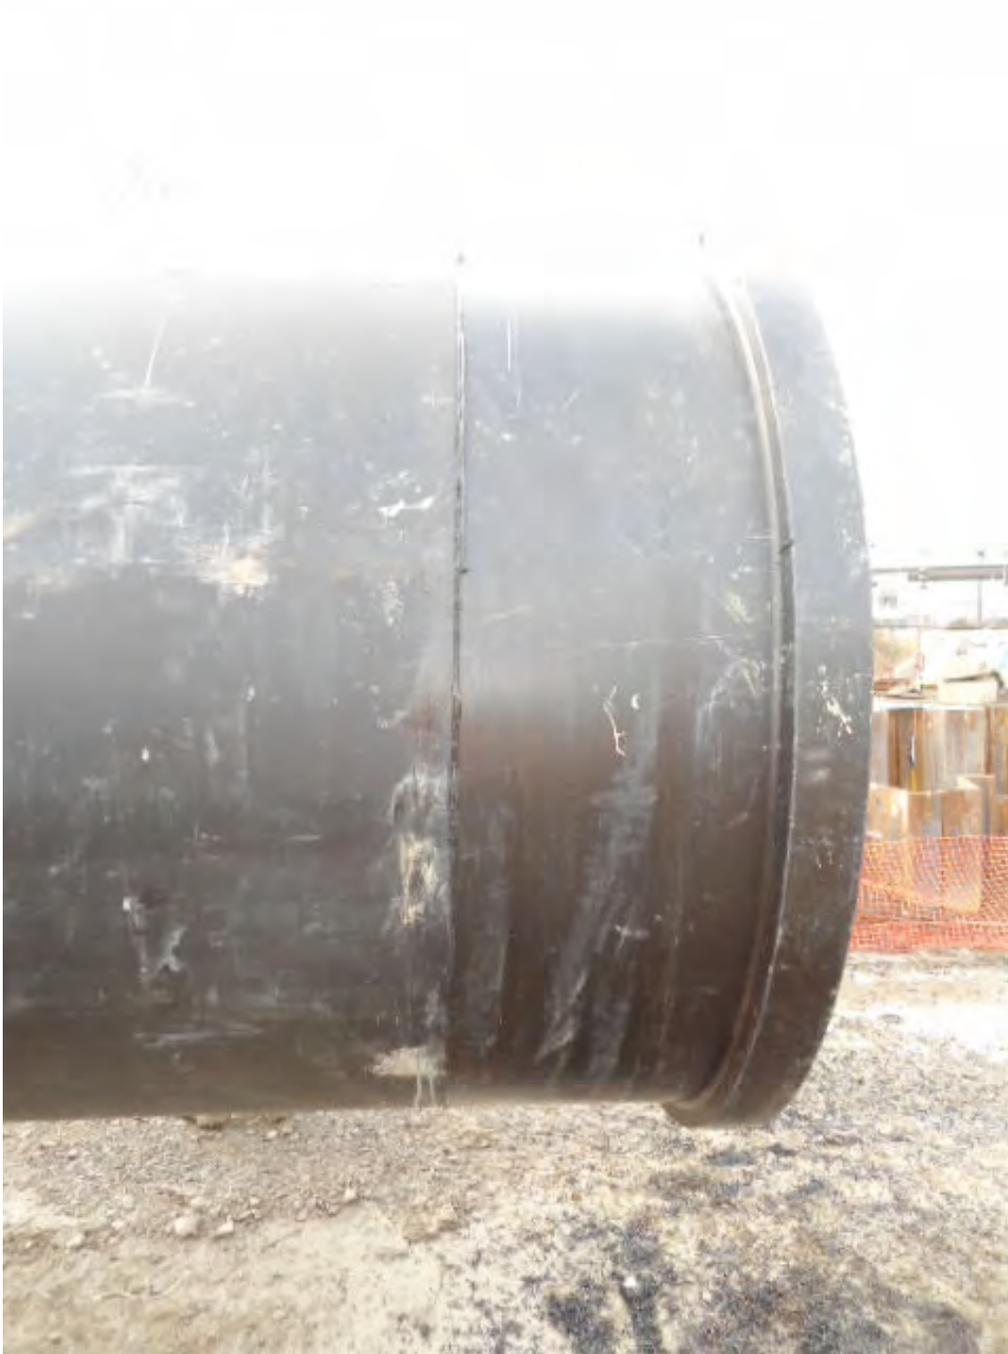
A butt-fused section of HDPE and a flange. The excess material HDPE extruded (bead) during fusion was removed as the pipe cooled (facing west).

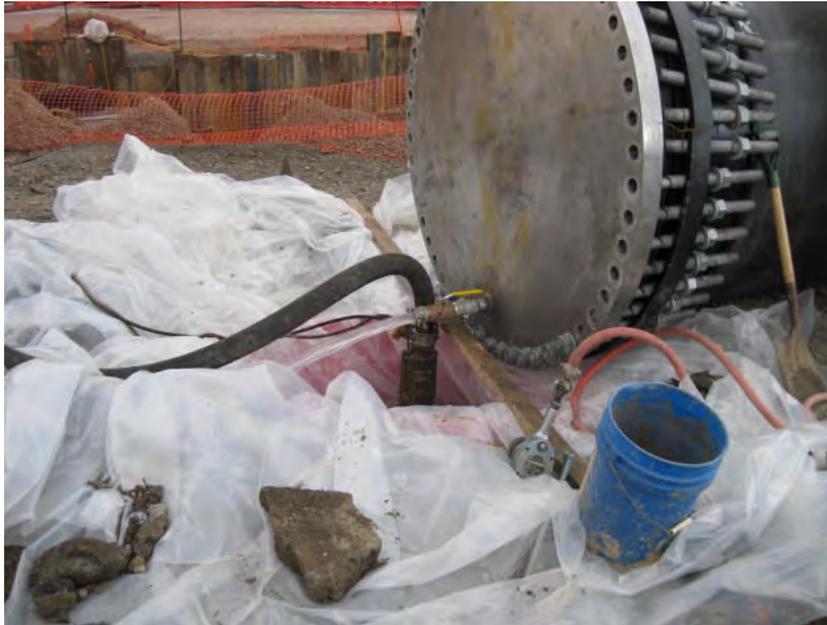
View of HDPE draining after leak test.
