Certification Statement	I
1. Introduction	1
1.1 General	1
1.2 Engineering Certification Report Organization	2
1.3 Site History	3
1.4 Location and Physical Setting	3

CLIENT: NYSEG	SITE NAME: Binghamton Court Street Former MGP Site
PROJECT #: 13074.001	SITE LOCATION: Binghamton, New York
PHOTOGRAPH #: 001

Appendix C – Photographs

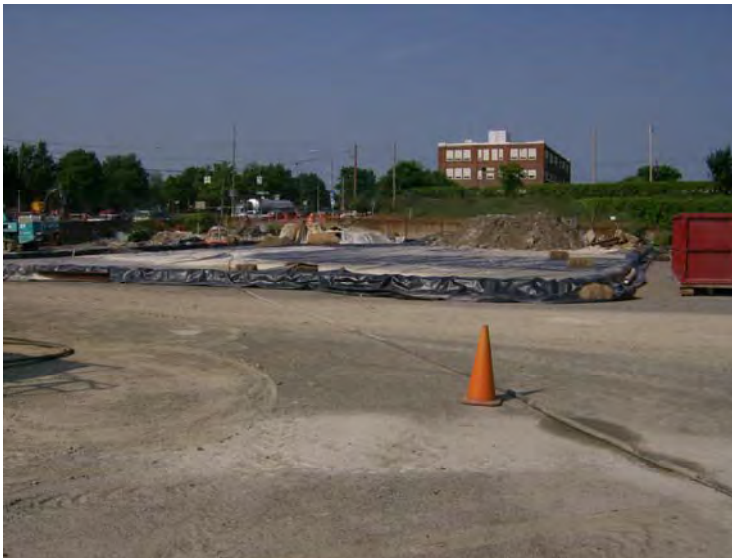
PHOTOGRAPHER: DMB	
DATE: 8/1/2006	
DIRECTION: West	
COMMENT: Material staging area consisting of HDPE liner and hay bale berms constructed near southwest corner of the site.

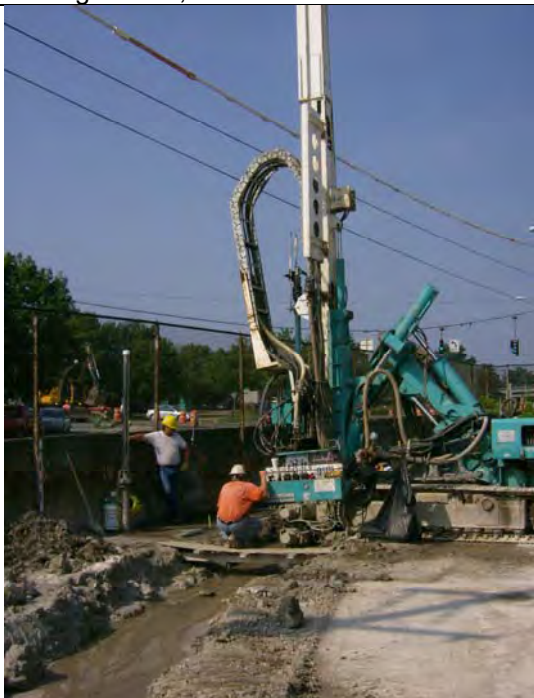
CLIENT: NYSEG	SITE NAME: Binghamton Court Street Former MGP Site
PROJECT #: 13074.001	SITE LOCATION: Binghamton, New York
PHOTOGRAPH #: 002

PHOTOGRAPHER: DMB	
DATE: 8/1/2006	
DIRECTION: Southwest	
COMMENT: Geo-Solutions performing jet-grouting in the vicinity of the 66-inch storm sewer.

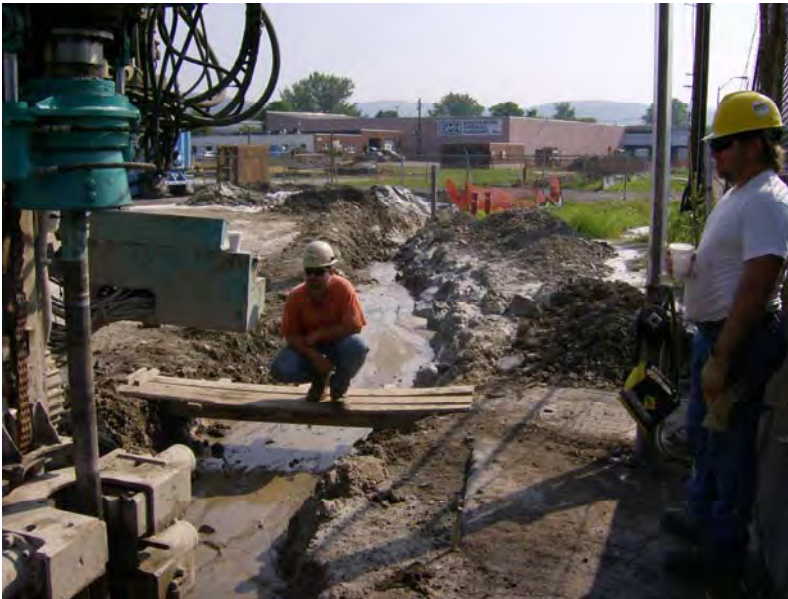
CLIENT: NYSEG	SITE NAME: Binghamton Court Street Former MGP Site
PROJECT #: 13074.001	SITE LOCATION: Binghamton, New York
PHOTOGRAPH #: 003

PHOTOGRAPHER: DMB	
DATE: 8/1/2006	
DIRECTION: East	
COMMENT: Geo-Solutions performing jet-grouting in the vicinity of the 66-inch storm sewer. Jet-grout spoils gravity drained to return pit and subsequently transferred to material staging area.

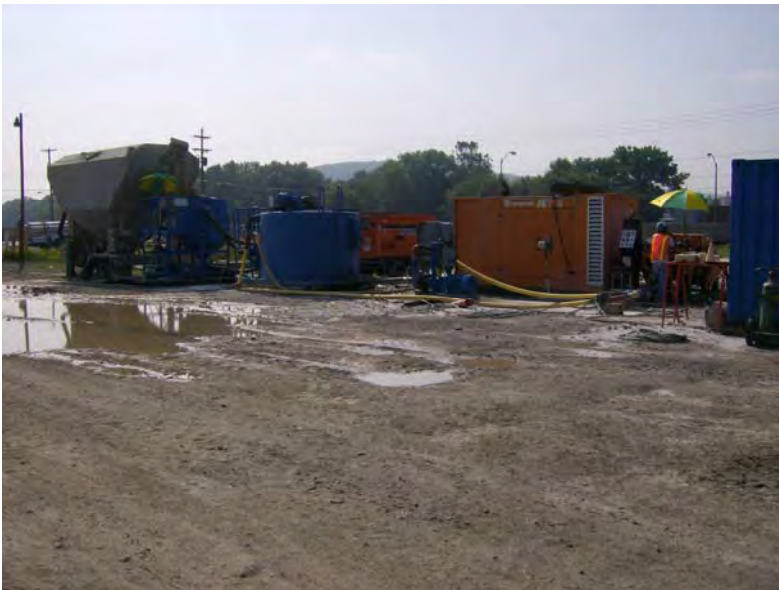
CLIENT: NYSEG	SITE NAME: Binghamton Court Street Former MGP Site
PROJECT #: 13074.001	SITE LOCATION: Binghamton, New York
PHOTOGRAPH #: 004

PHOTOGRAPHER: DMB	
DATE: 8/1/2006	
DIRECTION: South	
COMMENT: Geo-Solutions jet grout mixing and pumping equipment.

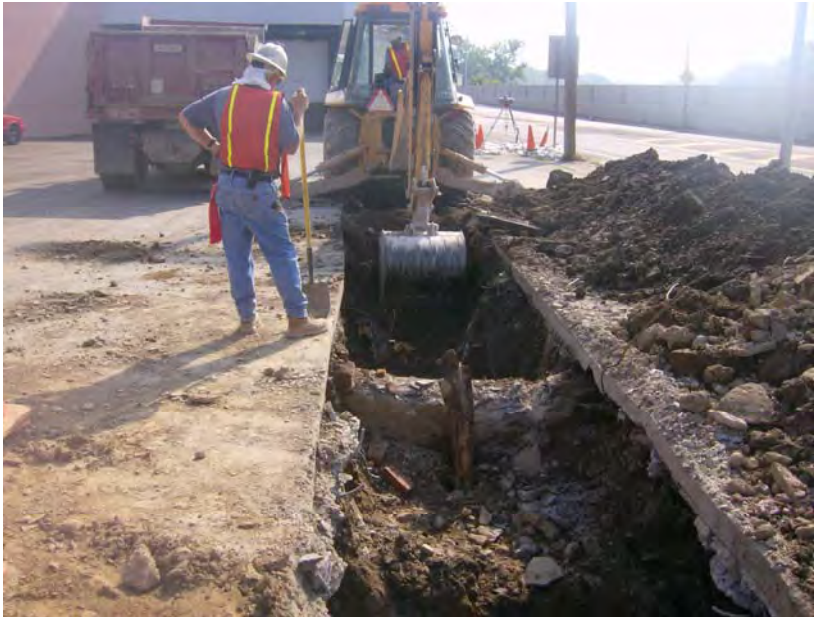
CLIENT: NYSEG	SITE NAME: Binghamton Court Street Former MGP Site
PROJECT #: 13074.001	SITE LOCATION: Binghamton, New York
PHOTOGRAPH #: 005

PHOTOGRAPHER: DMB	
DATE: 8/2/2006	
DIRECTION: East	
COMMENT: Pre-trench excavation activities in the Binghamton Materials Handling, Inc. parking lot. Subsurface concrete walls and C&D fill material encountered in this portion of the site.

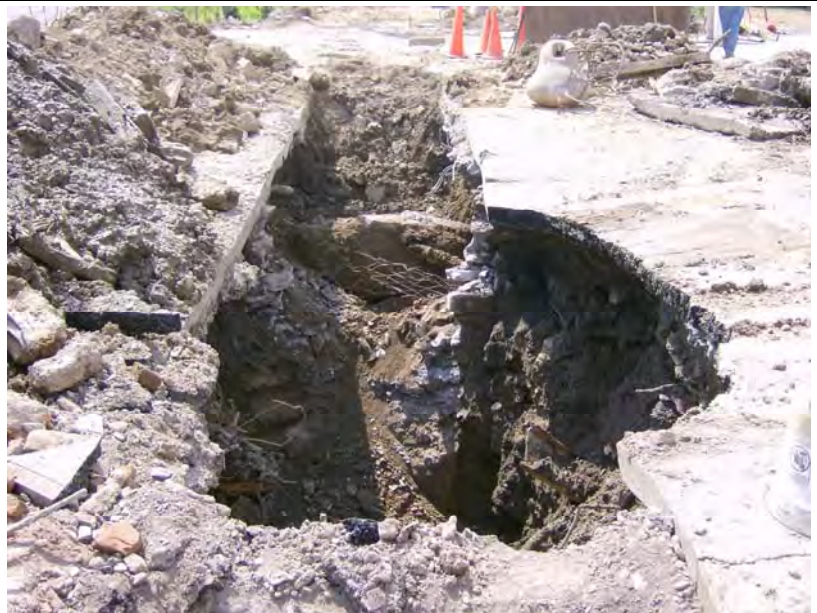
CLIENT: NYSEG	SITE NAME: Binghamton Court Street Former MGP Site
PROJECT #: 13074.001	SITE LOCATION: Binghamton, New York
PHOTOGRAPH #: 006

PHOTOGRAPHER: DMB	
DATE: 8/2/2006	
DIRECTION: West	
COMMENT: Pre-trench excavation activities in the Binghamton Materials Handling, Inc. parking lot. Subsurface concrete walls and C&D fill material encountered in this portion of the site.

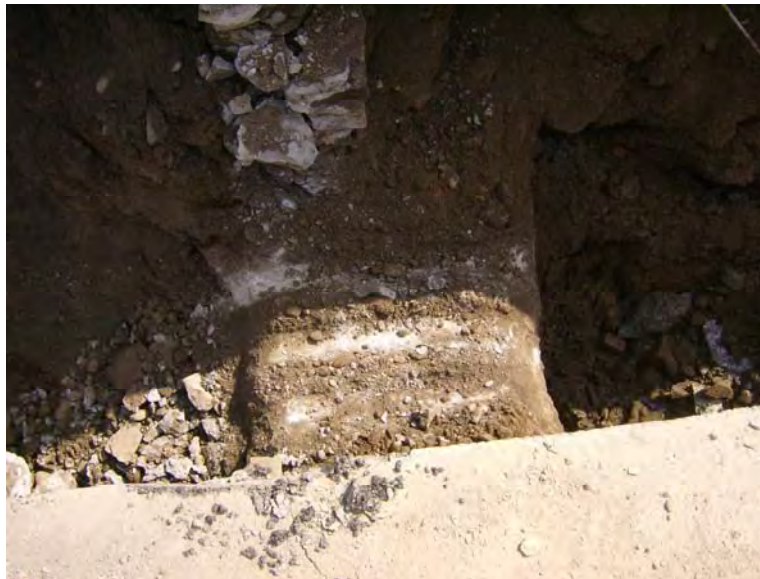
CLIENT: NYSEG	SITE NAME: Binghamton Court Street Former MGP Site
PROJECT #: 13074.001	SITE LOCATION: Binghamton, New York
PHOTOGRAPH #: 007

PHOTOGRAPHER: DMB	
DATE: 8/2/2006	
DIRECTION: South	
COMMENT: Subsurface concrete wall encountered during pre-trench excavation activities in Binghamton Materials Handling, Inc. parking lot.

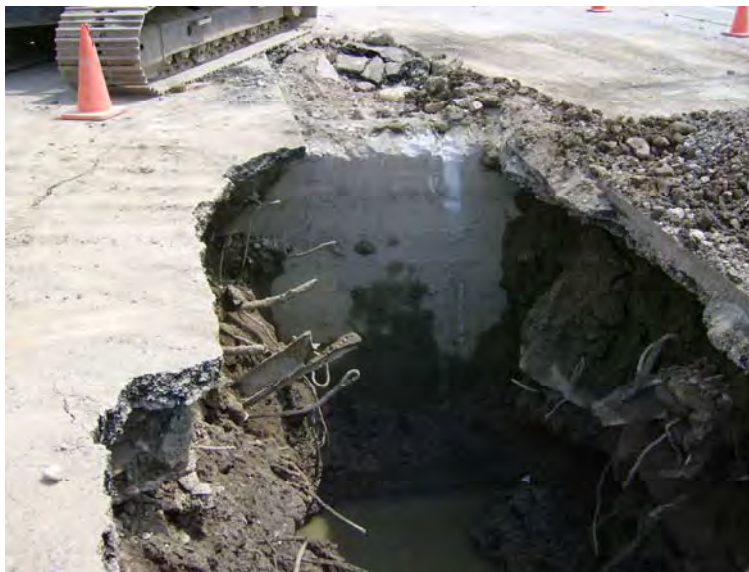
CLIENT: NYSEG	SITE NAME: Binghamton Court Street Former MGP Site
PROJECT #: 13074.001	SITE LOCATION: Binghamton, New York
PHOTOGRAPH #: 008

PHOTOGRAPHER: DMB	
DATE: 8/3/2006	
DIRECTION: East	
COMMENT: Subsurface concrete wall encountered during pre-trench excavation activities in Binghamton Materials Handling, Inc. parking lot.

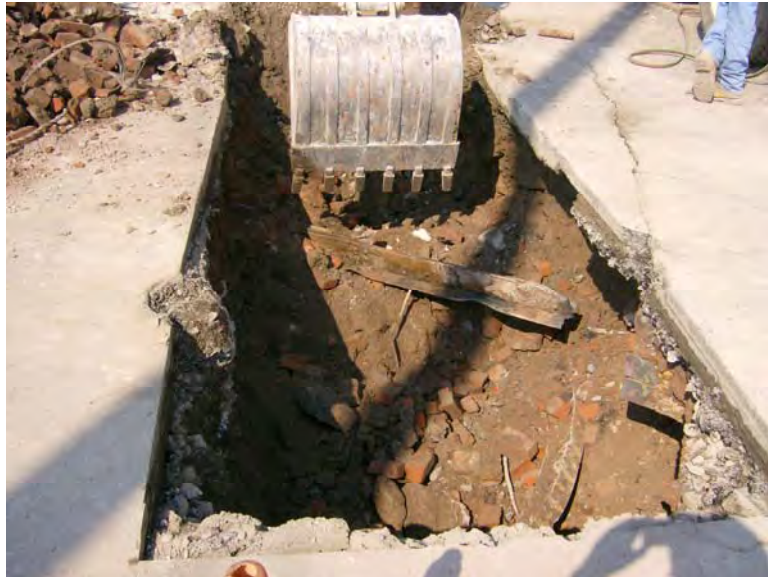
CLIENT: NYSEG	SITE NAME: Binghamton Court Street Former MGP Site
PROJECT #: 13074.001	SITE LOCATION: Binghamton, New York
PHOTOGRAPH #: 009

PHOTOGRAPHER: DMB	
DATE: 8/7/2006	
DIRECTION: East	
COMMENT: C&D fill material encountered under Binghamton Materials Handling, Inc. parking lot during pre-trench excavation activities.

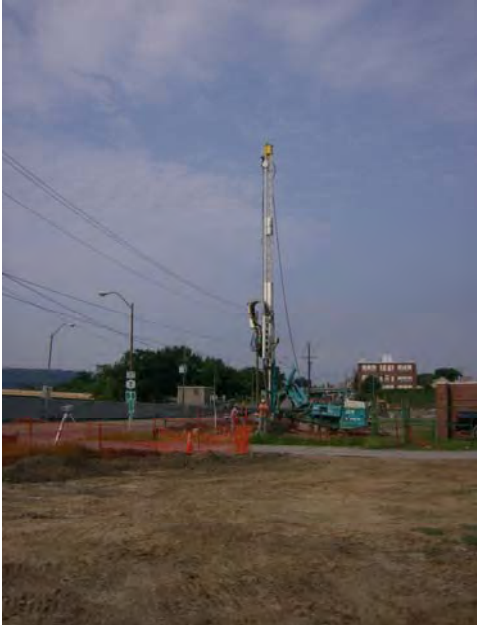
CLIENT: NYSEG	SITE NAME: Binghamton Court Street Former MGP Site
PROJECT #: 13074.001	SITE LOCATION: Binghamton, New York
PHOTOGRAPH #: 011

PHOTOGRAPHER: DMB	
DATE: 8/10/2006	
DIRECTION: West	
COMMENT: Geo-Solutions performing jet-grouting in the vicinity of subsurface utilities in front of the gas control building.

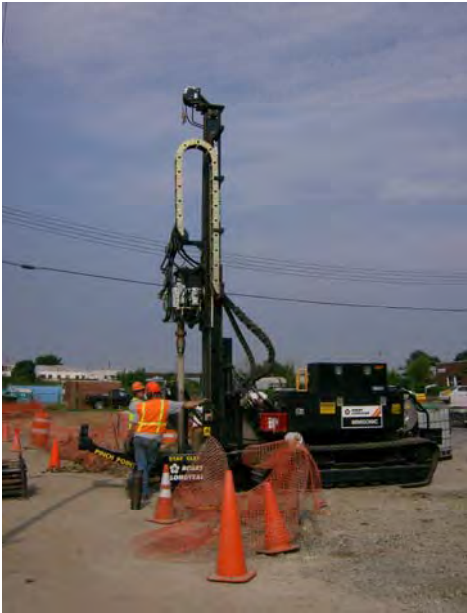
CLIENT: NYSEG	SITE NAME: Binghamton Court Street Former MGP Site
PROJECT #: 13074.001	SITE LOCATION: Binghamton, New York
PHOTOGRAPH #: 012

PHOTOGRAPHER: DMB	
DATE: 8/10/2006	
DIRECTION: West	
COMMENT: Boart Longyear completing sonic drilling through subsurface concrete walls encountered in Binghamton Materials Handling, Inc. parking lot during pre-trench excavation activities to facilitate jet-grouting in this portion of the site.

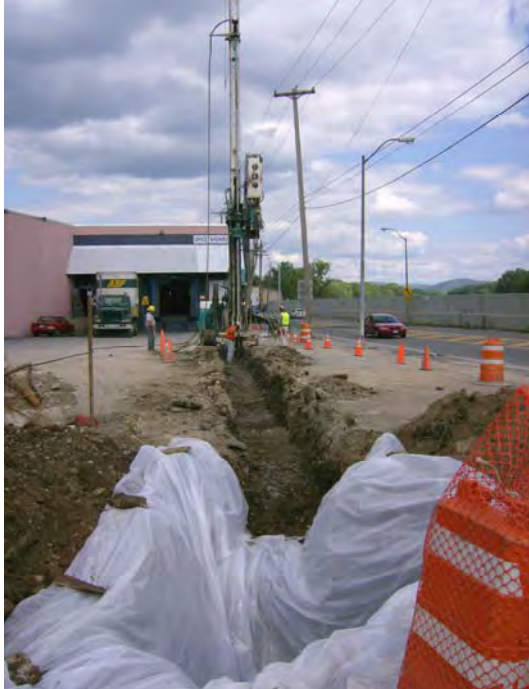
CLIENT: NYSEG	SITE NAME: Binghamton Court Street Former MGP Site
PROJECT #: 13074.001	SITE LOCATION: Binghamton, New York
PHOTOGRAPH #: 013

PHOTOGRAPHER: DMB	
DATE: 8/16/2006	
DIRECTION: East	
COMMENT: Geo-Solutions completing jet-grouting in the Binghamton Materials Handling, Inc. parking lot.

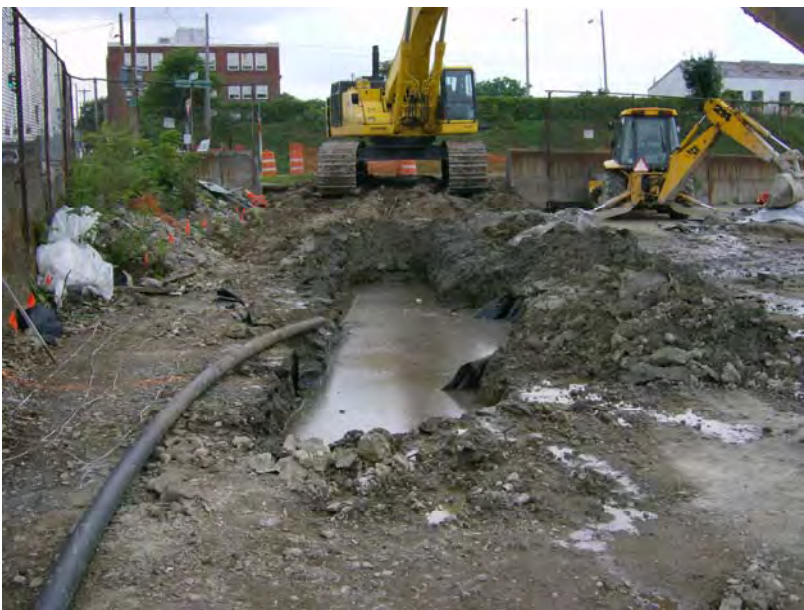
CLIENT: NYSEG	SITE NAME: Binghamton Court Street Former MGP Site
PROJECT #: 13074.001	SITE LOCATION: Binghamton, New York
PHOTOGRAPH #: 014

PHOTOGRAPHER: DMB	
DATE: 8/28/2006	
DIRECTION: West	
COMMENT: Geo-Solutions conducting slurry-supported trench excavation with the long-stick excavator west of the 66-inch storm sewer.

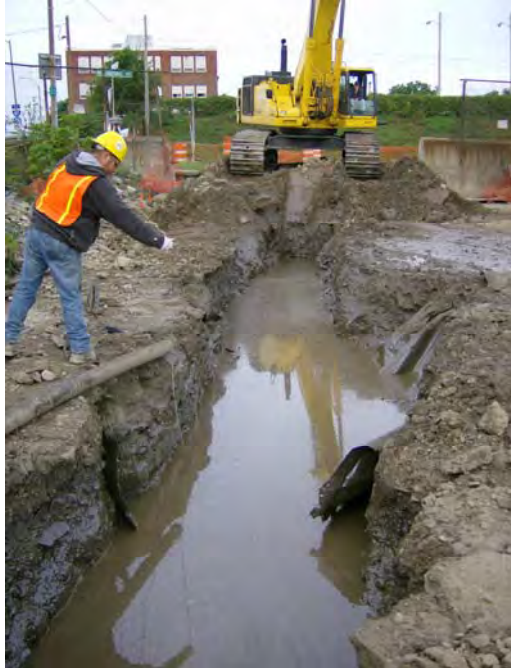
CLIENT: NYSEG	SITE NAME: Binghamton Court Street Former MGP Site
PROJECT #: 13074.001	SITE LOCATION: Binghamton, New York
PHOTOGRAPH #: 015

PHOTOGRAPHER: DMB	
DATE: 8/31/2006	
DIRECTION: West	
COMMENT: Geo-Solutions conducting slurry-supported trench excavation west of the 66-inch storm sewer. Geo-Solutions taking measurements to verify depth of excavation.

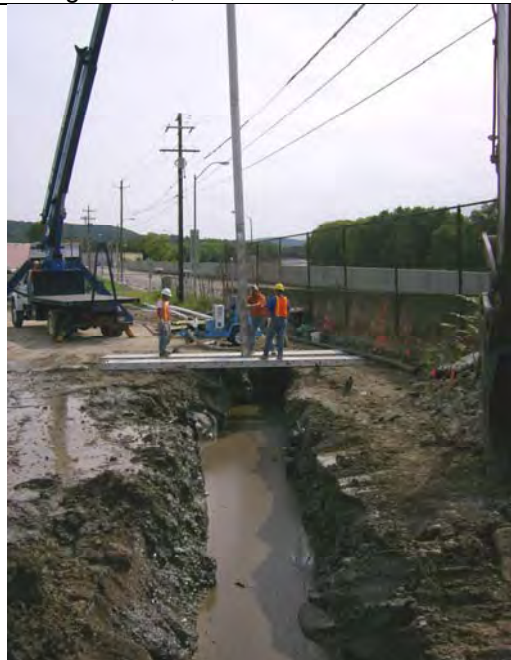
CLIENT: NYSEG	SITE NAME: Binghamton Court Street Former MGP Site
PROJECT #: 13074.001	SITE LOCATION: Binghamton, New York
PHOTOGRAPH #: 016

PHOTOGRAPHER: DMB	
DATE: 8/31/2006	
DIRECTION: East	
COMMENT: Geo-Solutions installing DNAPL recovery well in barrier wall trench excavation west of 66-inch storm sewer.

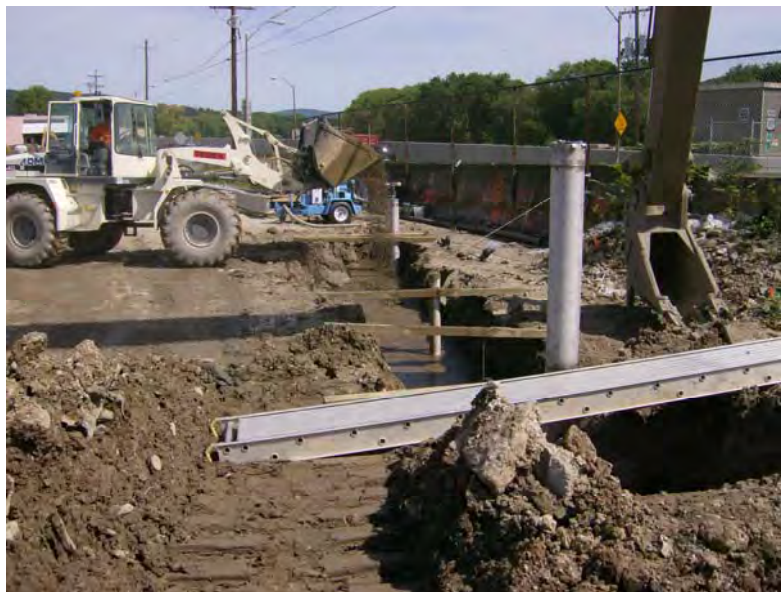
CLIENT: NYSEG	SITE NAME: Binghamton Court Street Former MGP Site
PROJECT #: 13074.001	SITE LOCATION: Binghamton, New York
PHOTOGRAPH #: 018

PHOTOGRAPHER: DMB	
DATE: 8/31/2006	
DIRECTION: East	
COMMENT: Geo-Solutions placing pea gravel backfill into barrier wall excavation west 66-inch storm sewer.

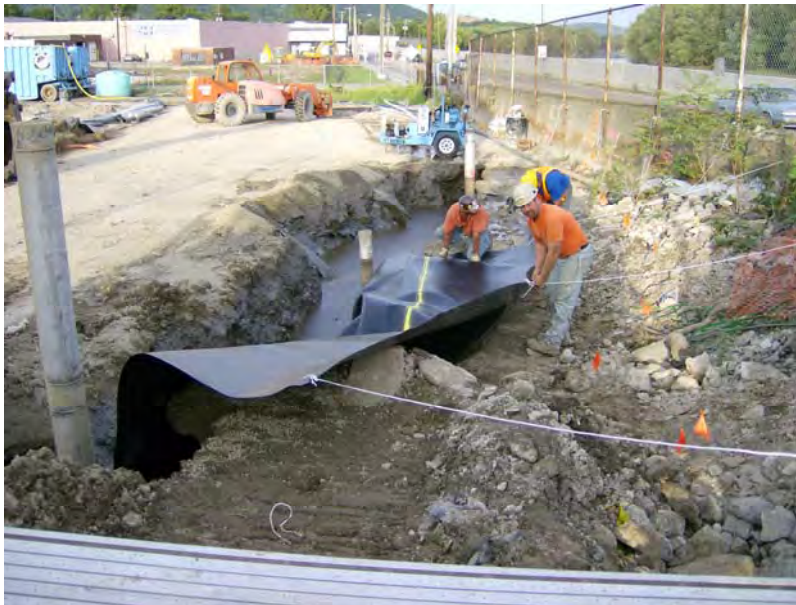
CLIENT: NYSEG	SITE NAME: Binghamton Court Street Former MGP Site
PROJECT #: 13074.001	SITE LOCATION: Binghamton, New York
PHOTOGRAPH #: 019

PHOTOGRAPHER: DMB	
DATE: 8/31/2006	
DIRECTION: East	
COMMENT: Geo-Solutions installing HDPE LNAPL barrier in barrier wall trench excavation west of 66-inch storm sewer.

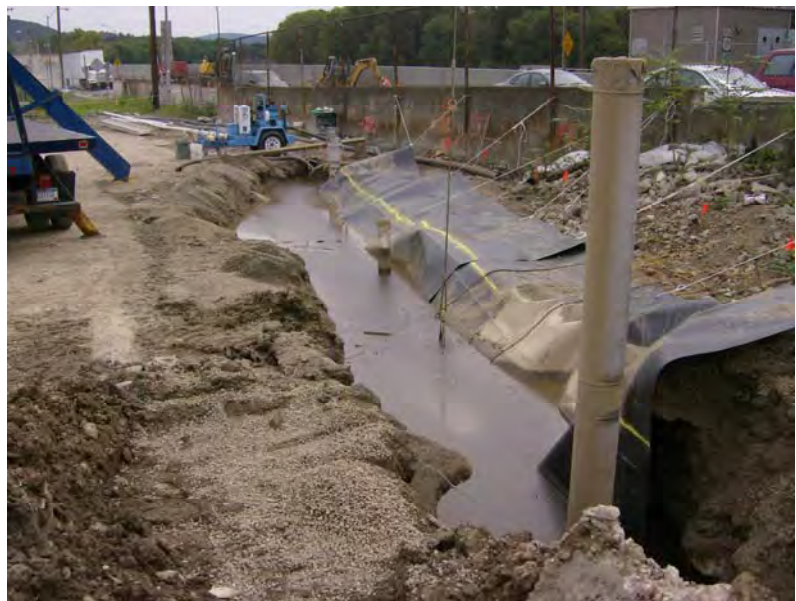
CLIENT: NYSEG	SITE NAME: Binghamton Court Street Former MGP Site
PROJECT #: 13074.001	SITE LOCATION: Binghamton, New York
PHOTOGRAPH #: 020

PHOTOGRAPHER: DMB	
DATE: 9/1/2006	
DIRECTION: East	
COMMENT: HDPE LNAPL barrier anchored in barrier wall trench excavation west of 66-inch storm sewer prior bio-polymer slurry degradation.

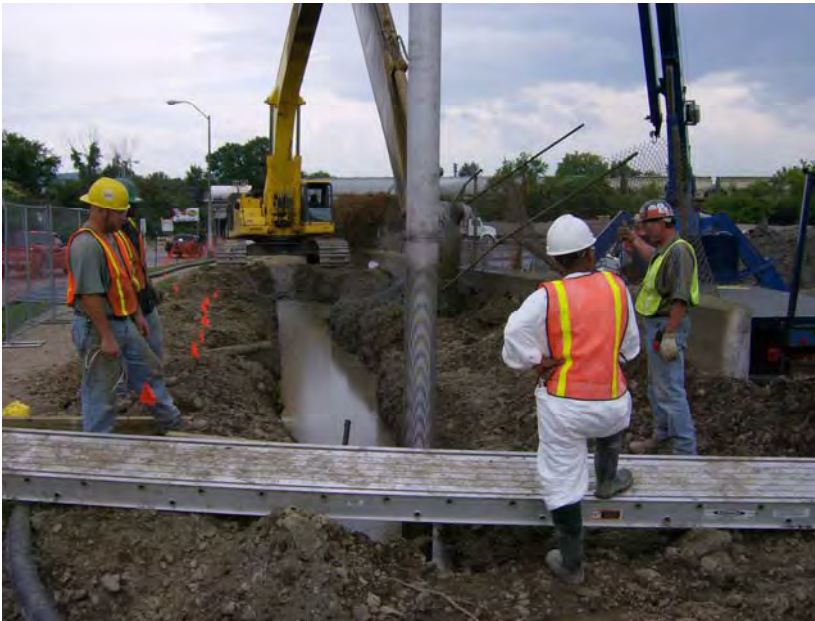
CLIENT: NYSEG	SITE NAME: Binghamton Court Street Former MGP Site
PROJECT #: 13074.001	SITE LOCATION: Binghamton, New York
PHOTOGRAPH #: 021

PHOTOGRAPHER: DMB	
DATE: 9/6/2006	
DIRECTION: North	
COMMENT: Geo-Solutions installing DNAPL recovery well in south end of barrier wall excavation along Brandywine Avenue.

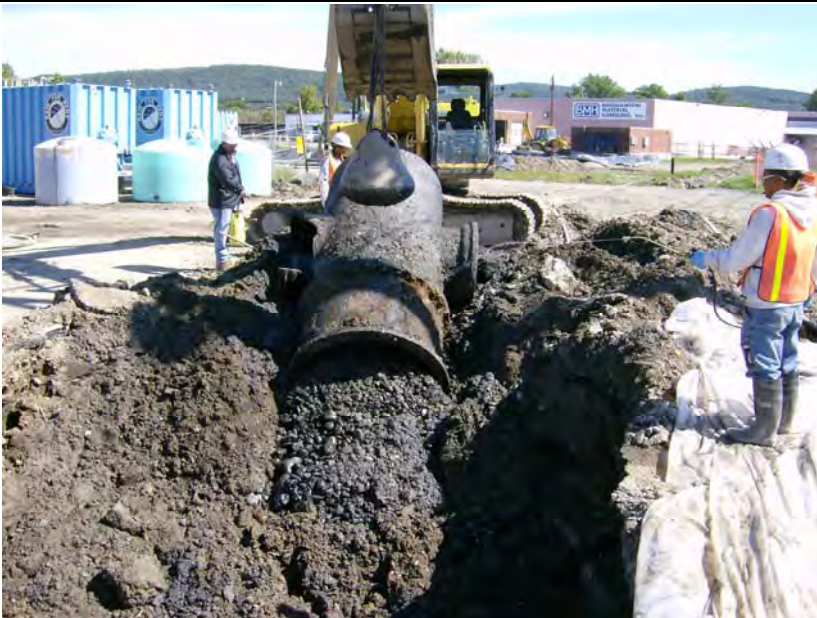
CLIENT: NYSEG	SITE NAME: Binghamton Court Street Former MGP Site
PROJECT #: 13074.001	SITE LOCATION: Binghamton, New York
PHOTOGRAPH #: 022

PHOTOGRAPHER: DMB	
DATE: 9/12/2006	
DIRECTION: Northeast	
COMMENT: Royal Environmental removing cast-iron structure associated with former MGP at station 204+70 located east of the 66-inch storm sewer jet grout panel.

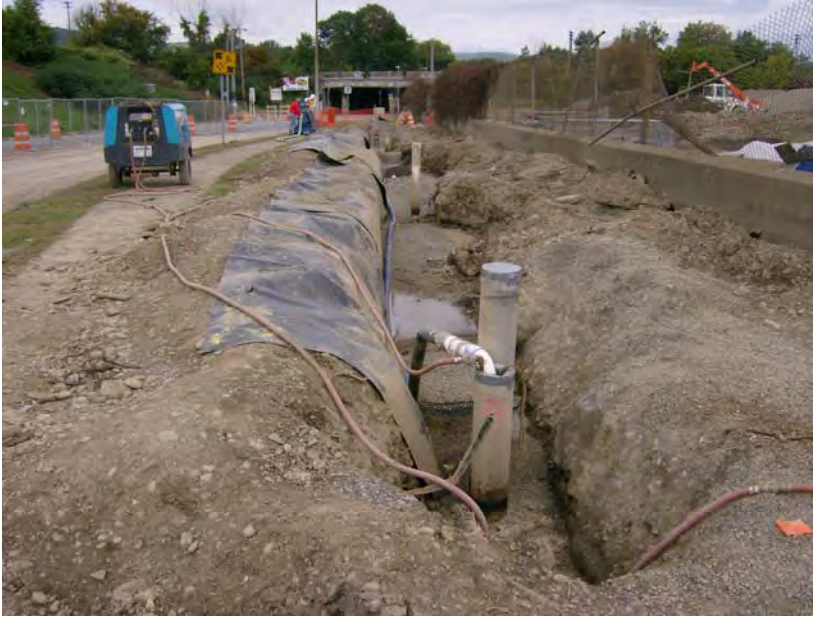
CLIENT: NYSEG	SITE NAME: Binghamton Court Street Former MGP Site
PROJECT #: 13074.001	SITE LOCATION: Binghamton, New York
PHOTOGRAPH #: 023

PHOTOGRAPHER: DMB	
DATE: 9/20/2006	
DIRECTION: North	
COMMENT: Geo-Solutions degrading bio-polymer slurry along Brandywine Avenue via recirculation through the barrier wall excavation after placement of pea gravel backfill.

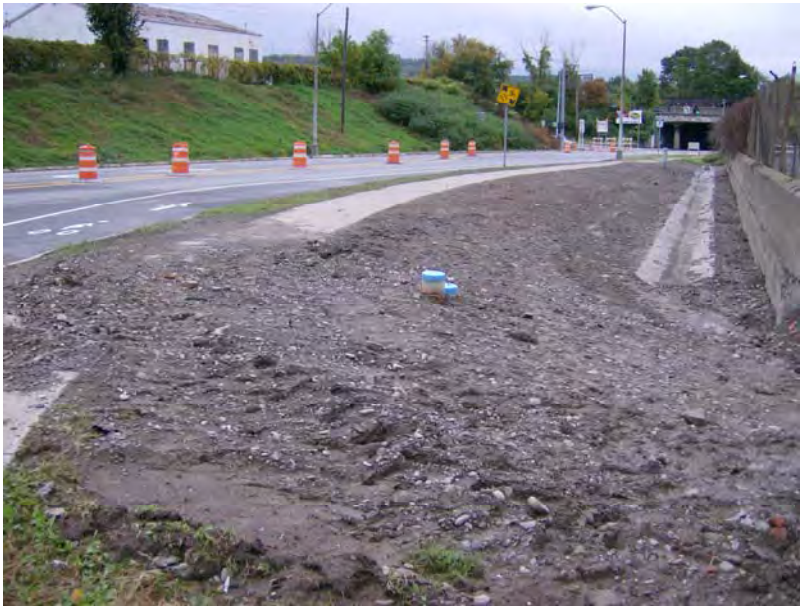
CLIENT: NYSEG	SITE NAME: Binghamton Court Street Former MGP Site
PROJECT #: 13074.001	SITE LOCATION: Binghamton, New York
PHOTOGRAPH #: 024

PHOTOGRAPHER: DMB	
DATE: 9/29/2006	
DIRECTION: North	
COMMENT: Barrier wall trench excavation along Brandywine Avenue completed with general fill (prior to top soil placement, sidewalk repairs, and installation of well vaults).

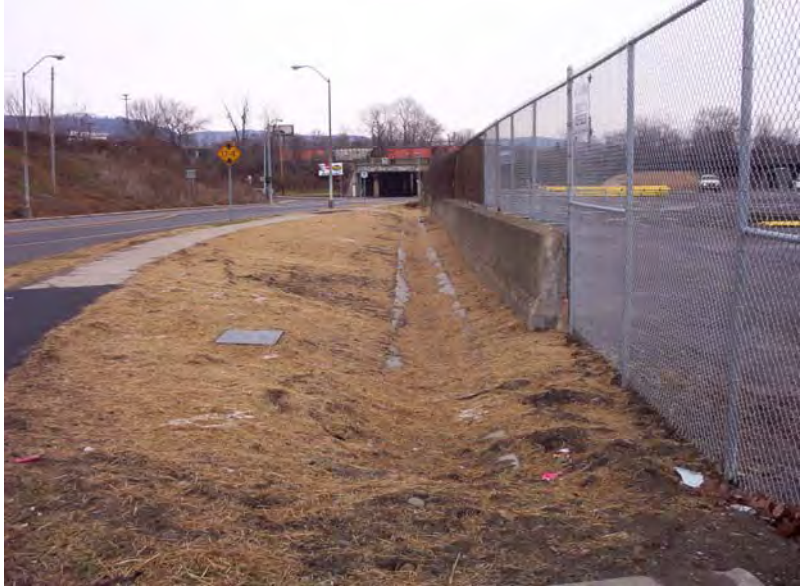
CLIENT: NYSEG	SITE NAME: Binghamton Court Street Former MGP Site
PROJECT #: 13074.001	SITE LOCATION: Binghamton, New York
PHOTOGRAPH #: 027

PHOTOGRAPHER: JRG	
DATE: 12/28/2006	
DIRECTION: North	
COMMENT: Barrier wall trench excavation along Brandywine Avenue completed with top soil placement, sidewalk repairs, installation of well vaults and new perimeter fencing.

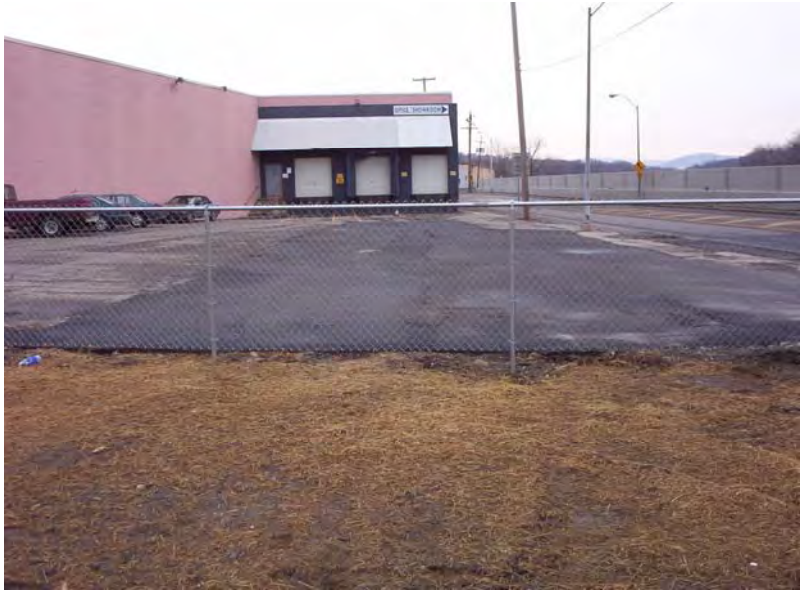
CLIENT: NYSEG	SITE NAME: Binghamton Court Street Former MGP Site
PROJECT #: 13074.001	SITE LOCATION: Binghamton, New York
PHOTOGRAPH #: 028

PHOTOGRAPHER: JRG	
DATE: 12/28/2006	
DIRECTION: East	
COMMENT: Pavement restoration in Binghamton Materials Handling, Inc. parking lot and installation of new perimeter fencing on eastern portion of the site.
